Contract #: 04-0120F4Cty: SF/ALA Rte: 80 PM: 13.2/13.9File #: 69.28**WELDING INSPECTION REPORT****Resident Engineer:**Pursell, Gary**Address:** 333 Burma Road**City:** Oakland, CA 94607**Report No:** WIR-014733**Date Inspected:** 04-Jun-2010**Project Name:** SAS Superstructure**OSM Arrival Time:** 700**Prime Contractor:** American Bridge/Fluor Enterprises, a JV**OSM Departure Time:** 1900**Contractor:** Zhenhua Port Machinery Company, Ltd (ZPMC), Changxing Island **Location:** Shanghai,China

WELDING INSPECTION REPORT

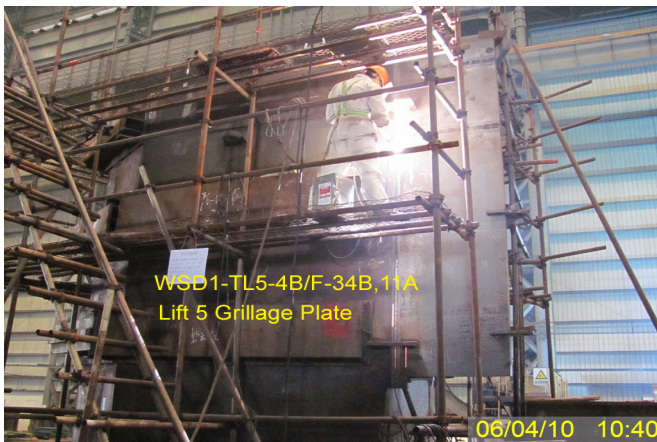
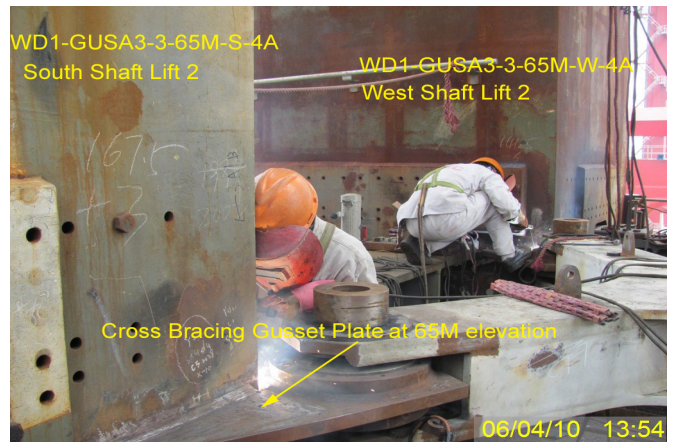
Unless otherwise noted, all work observed on this date appeared to generally comply with the applicable contract documents.
